# COMPREHENSIVE ASBESTOS SURVEY

COMMERCIAL BUILDING  
307/309 EAST MAIN STREET  
MONCK'S CORNER, SOUTH CAROLINA 29461

**CITY OF MONCK'S CORNER**  
**Attention: Mr. Jeffrey Lord**  
**PO Box 700**  
**Moncks Corner, SC 294461**  
**(843) 719-7910**

**Trident Environmental Services, Inc.**

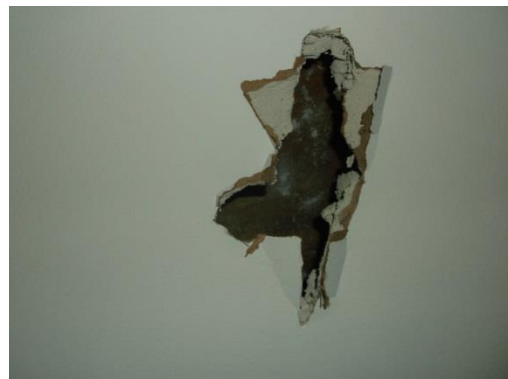
HOMOGENEOUS AREA 07  
DRYWALL

Asbestos fibers were identified in the Drywall/Joint Compound. Approximately 5,486 square feet is present and in good condition. This material is considered RACM – Friable Asbestos and is located on the walls and ceilings throughout the structure (see diagram).

The identified asbestos containing building materials (ACBM's) to include the item(s) listed above. All removal work of the identified ACBM's should be performed by a properly trained and licensed abatement contractor prior to the planned renovation/demolition activities.

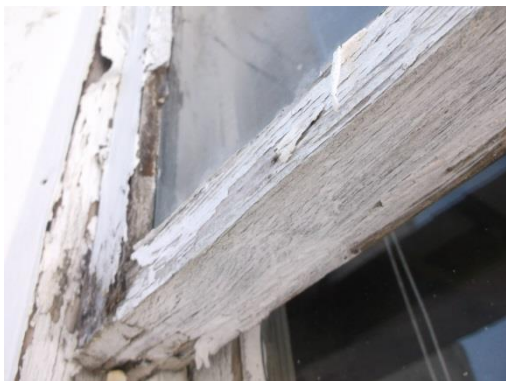
HOMOGENEOUS AREA 10  
WINDOW GLAZE

Asbestos fibers were identified in the Window Glaze. Approximately 44 square feet is present and in good condition. This material is considered RACM – Friable Asbestos and is located on exterior windows.

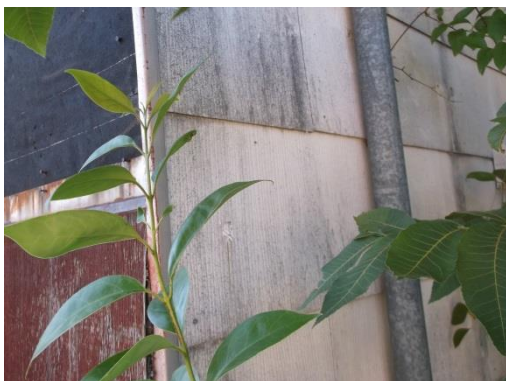
HOMOGENEOUS AREA 12  
TRANSITE SIDING

Asbestos fibers were identified in the Transite Siding. Approximately 1,000 square feet is present and in good condition. This material is considered Category II – Non Friable Asbestos and is located on the exterior of the building.
